Tin Whisker Observations
on Tin-Coated Copper Bus Bar
Obtained from
“A Large Paper Mill in Sweden”

Jay Brusse/Dell Perot Systems at
NASA Goddard Space Flight Center
December 2009
Jay.A.Brusse@nasa.gov

Images from 2009 Arcing Event @ Paper Mill in Sweden

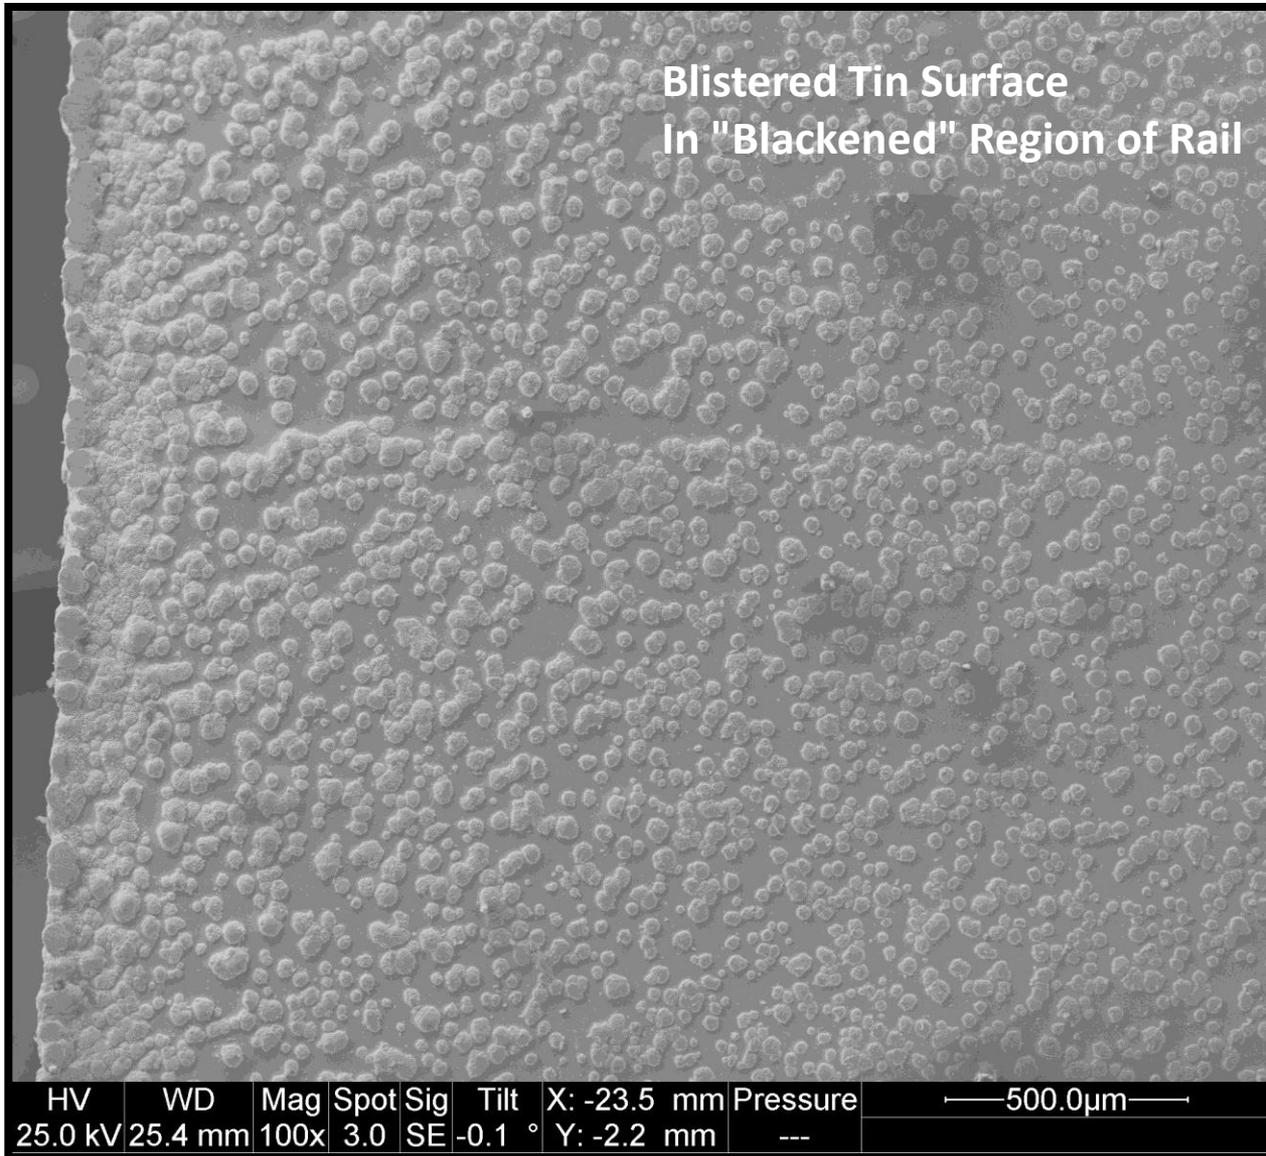
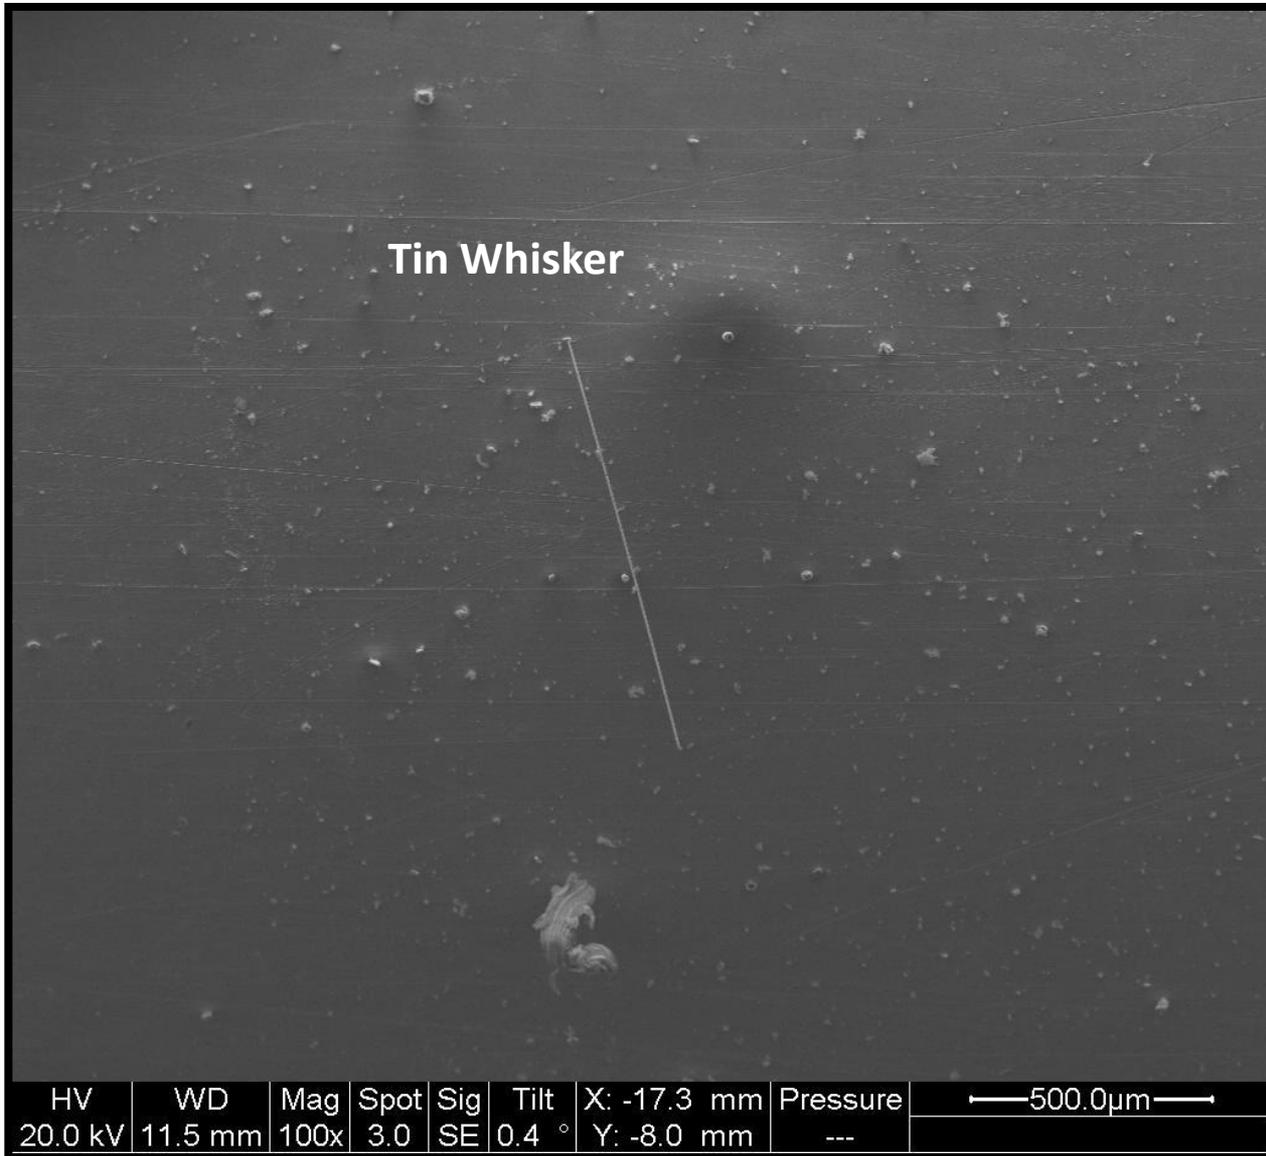
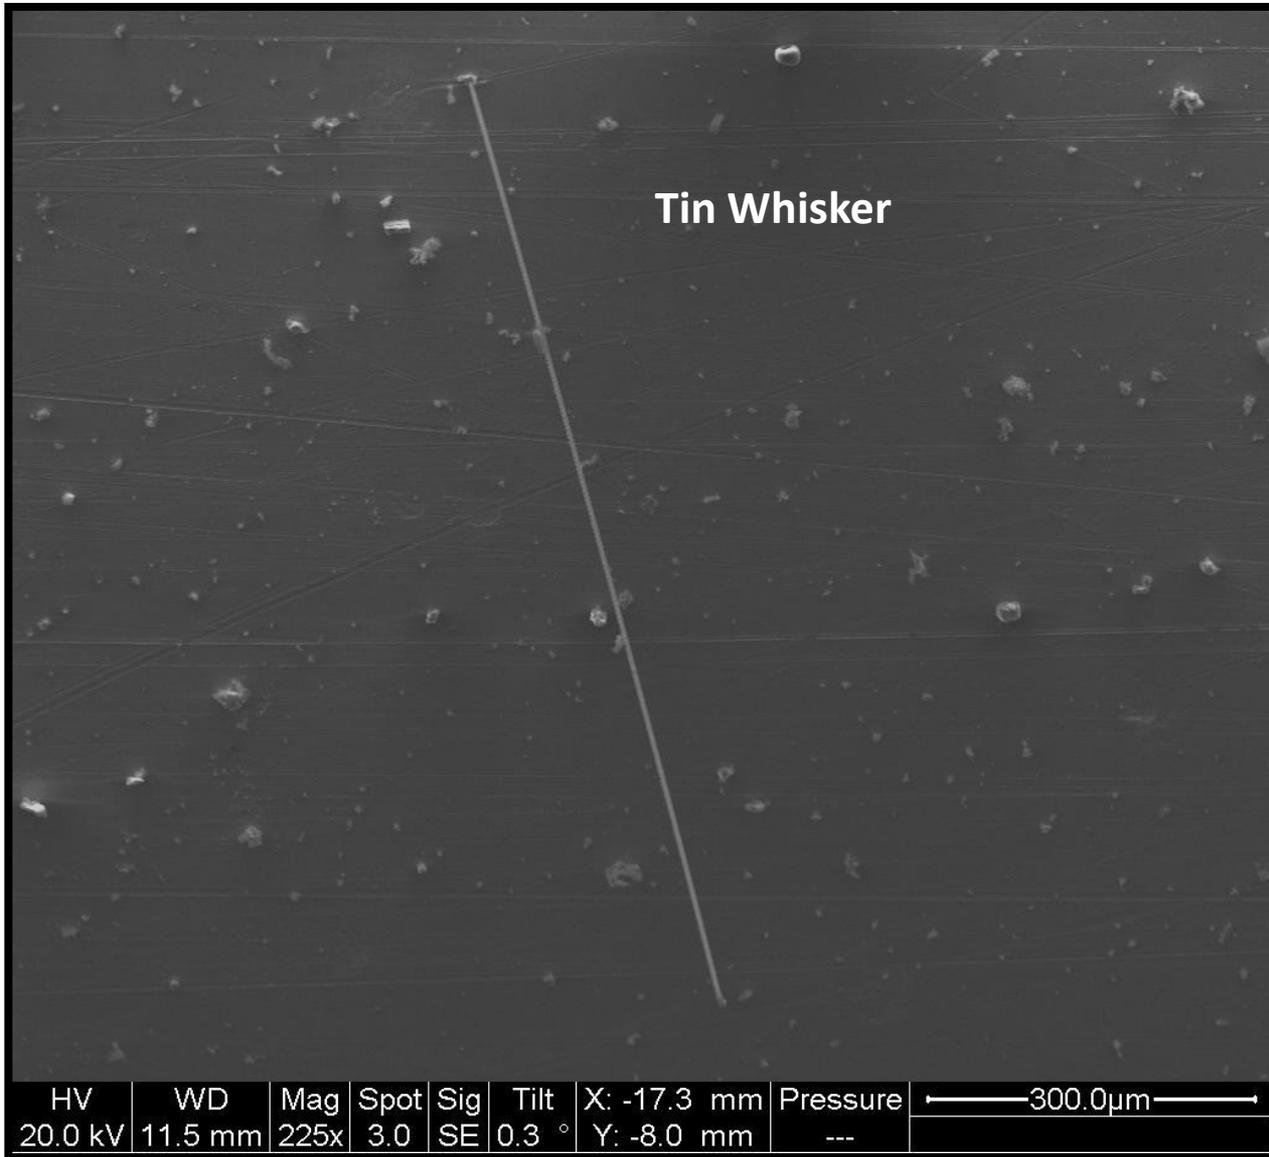
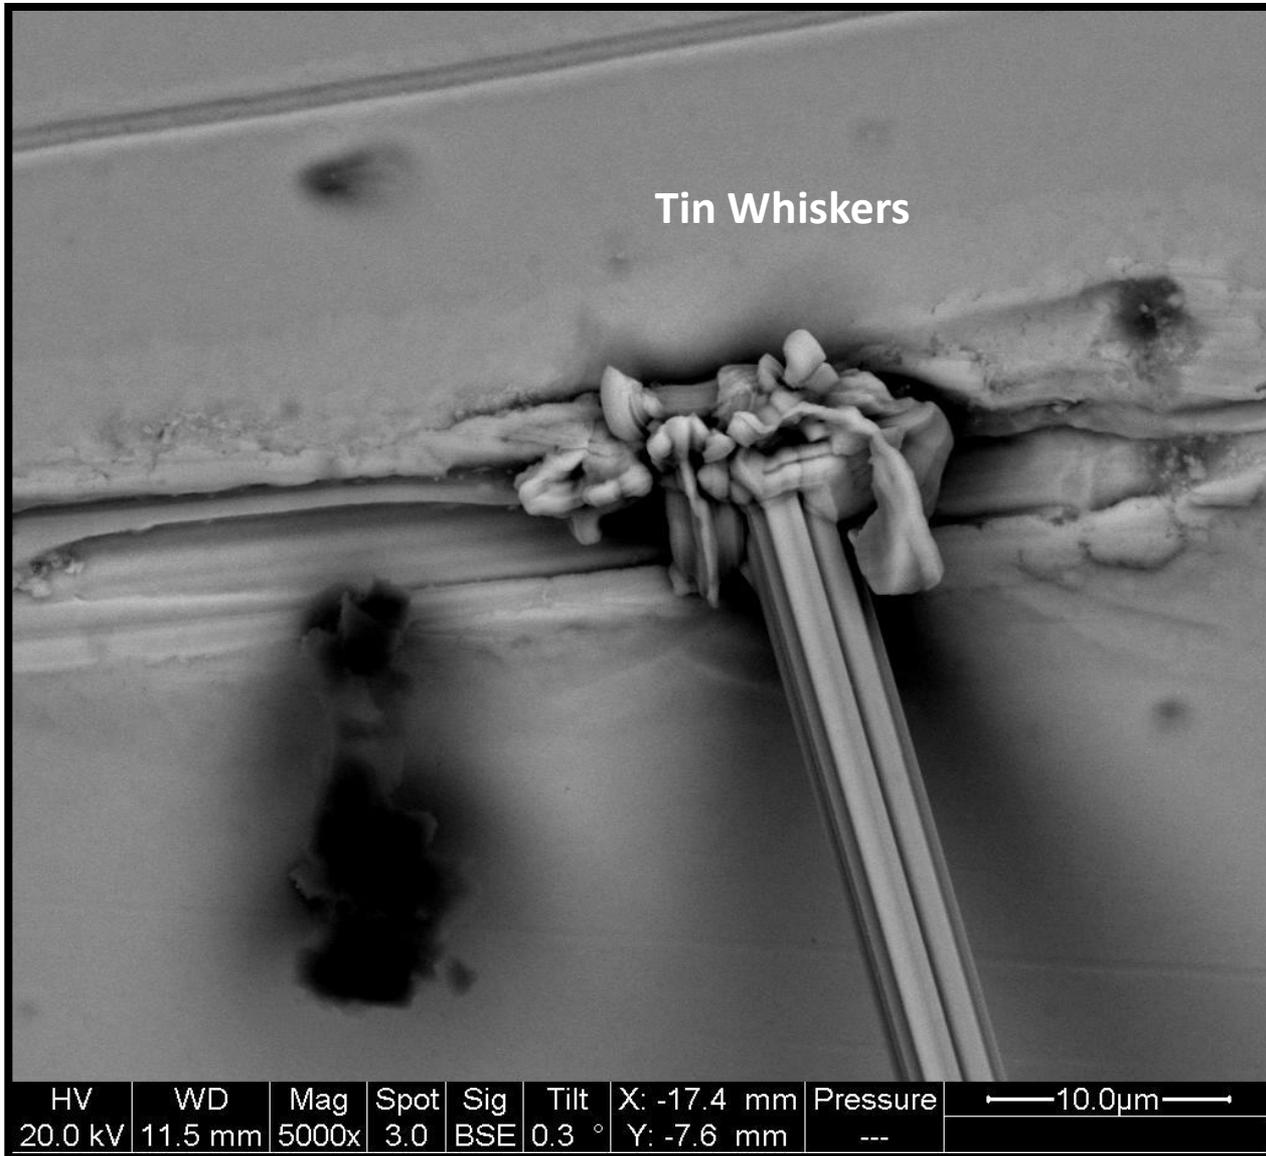
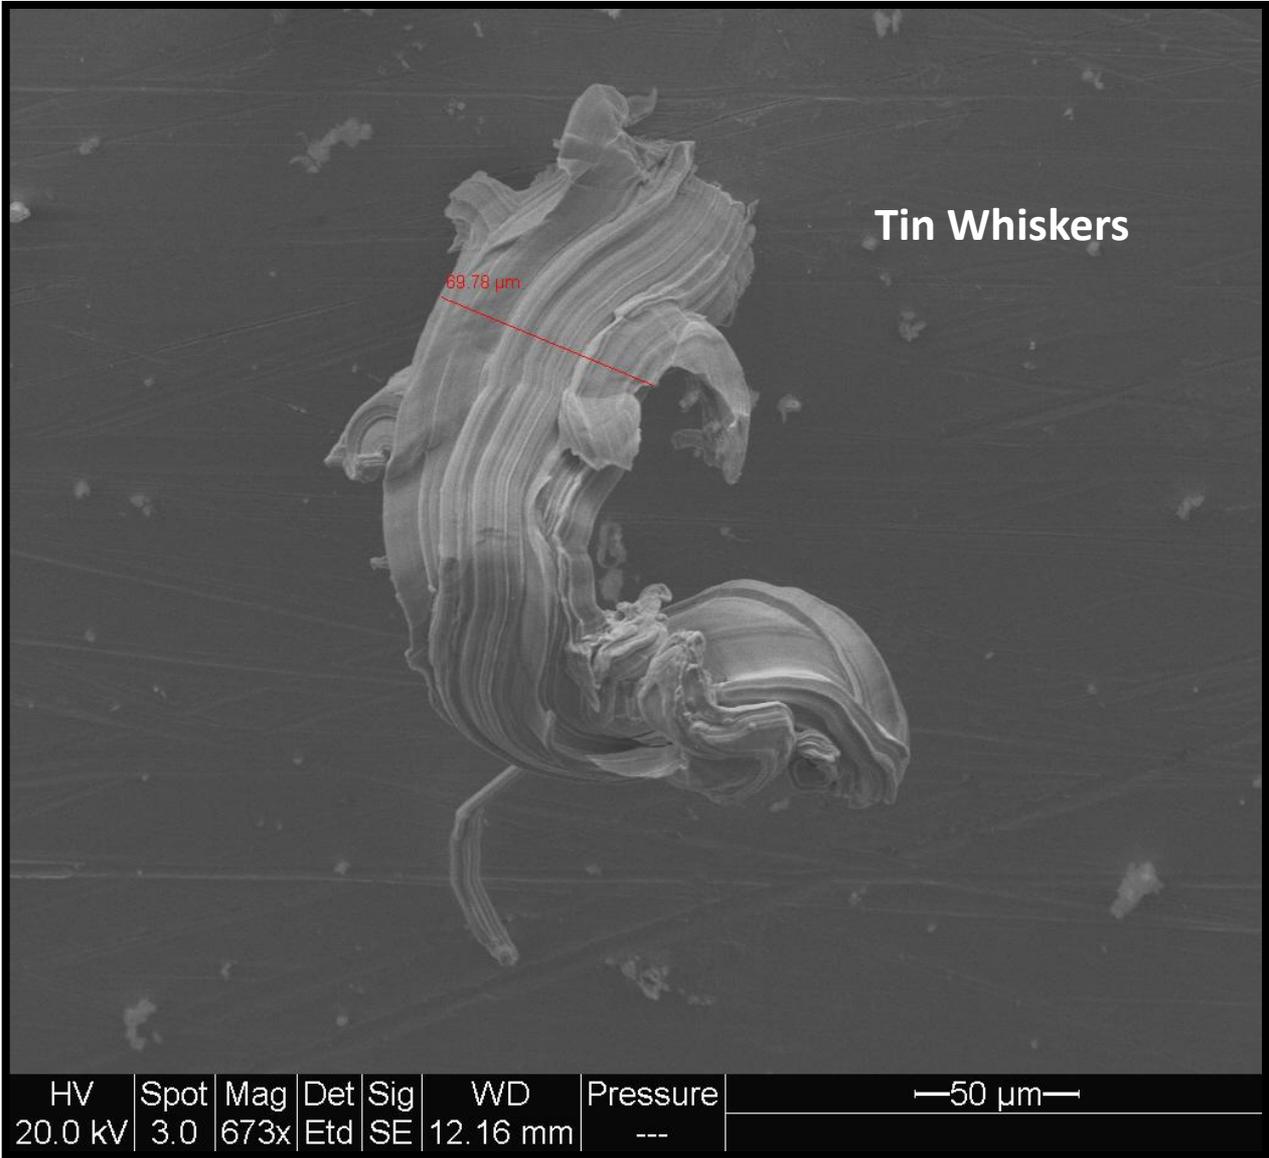
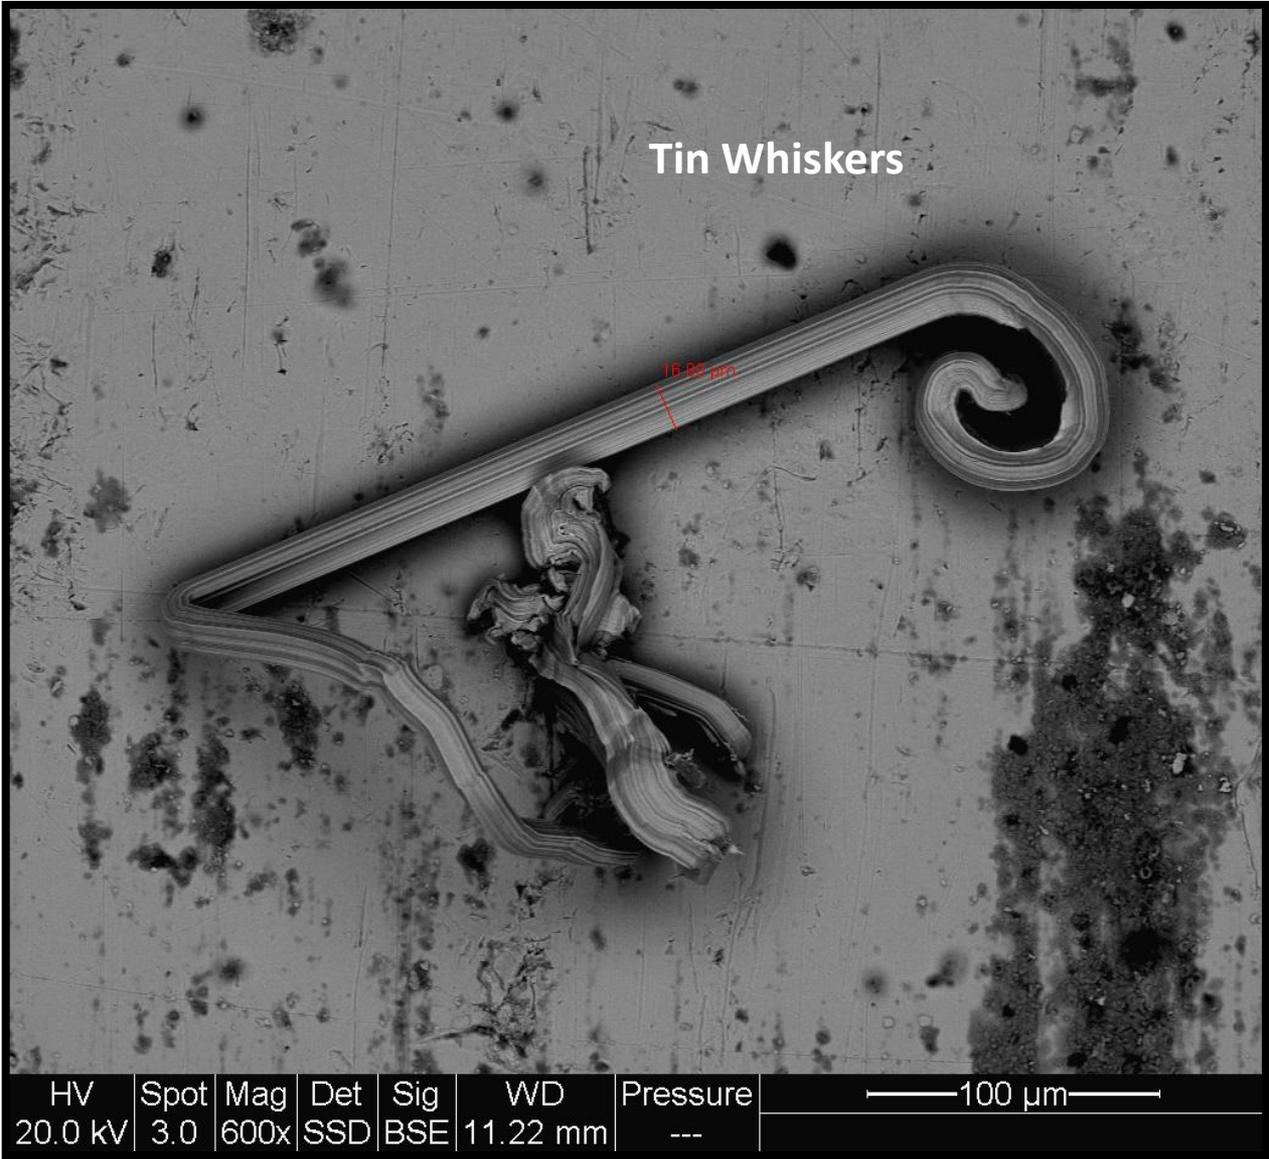
Blistered Tin Surface
In "Blackened" Region of Rail

- Very low density near the cut end of bus bar
- Localized darkening, blistering and flaking of the tin surface finish was observed
 - Most noticeable in region with highest tin whisker density.

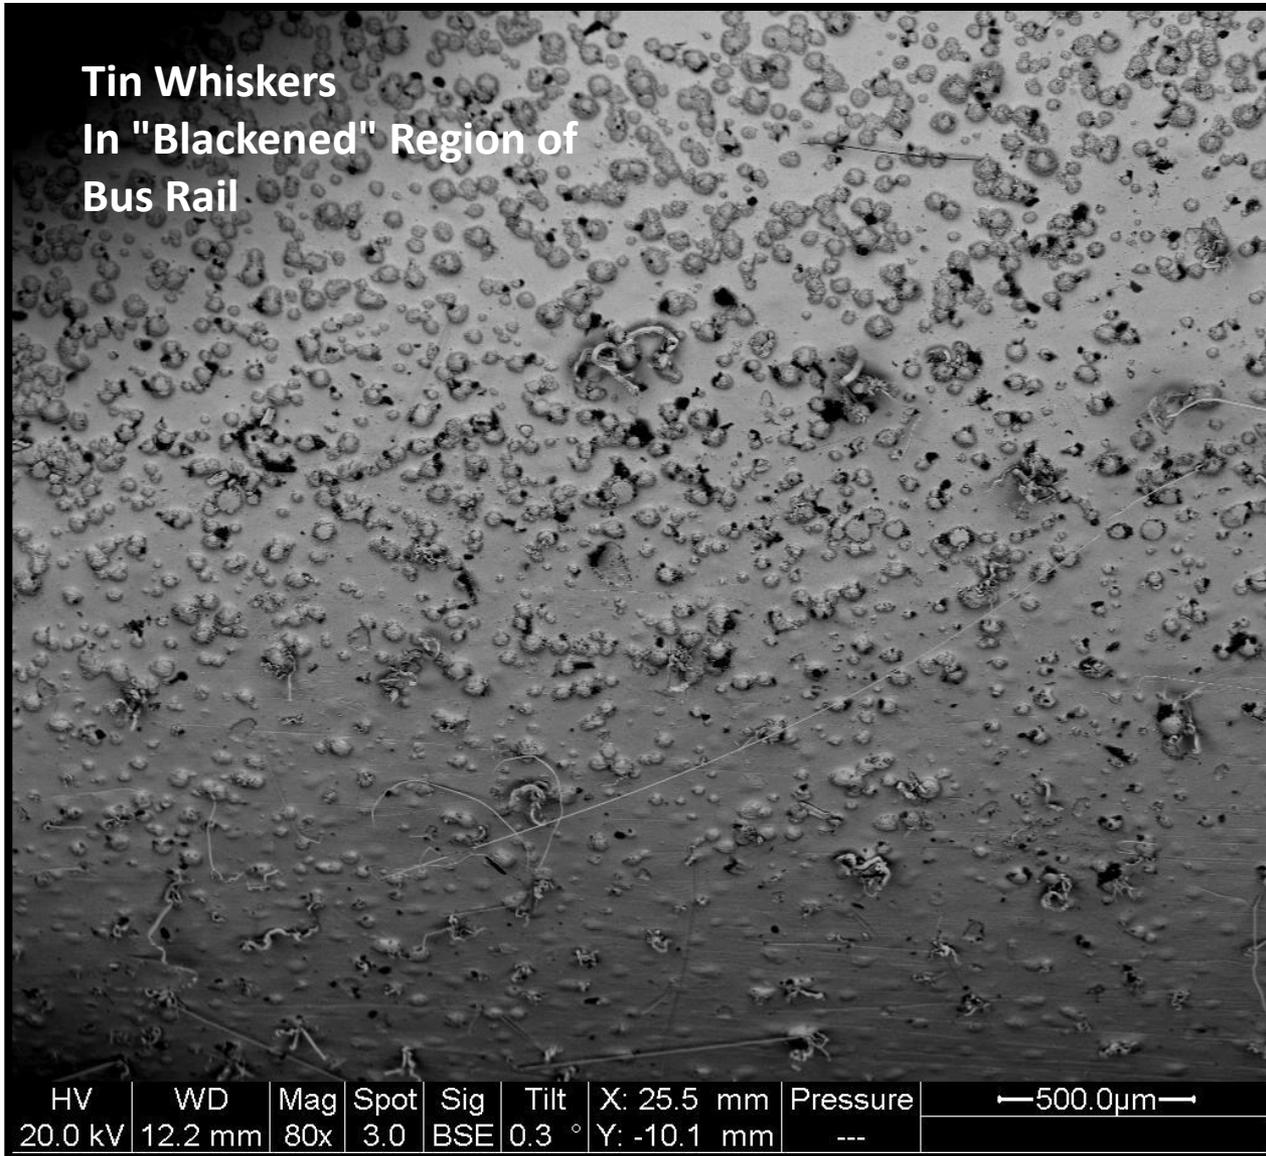
**Tin Whiskers
In "Blackened" Region of
Bus Rail**

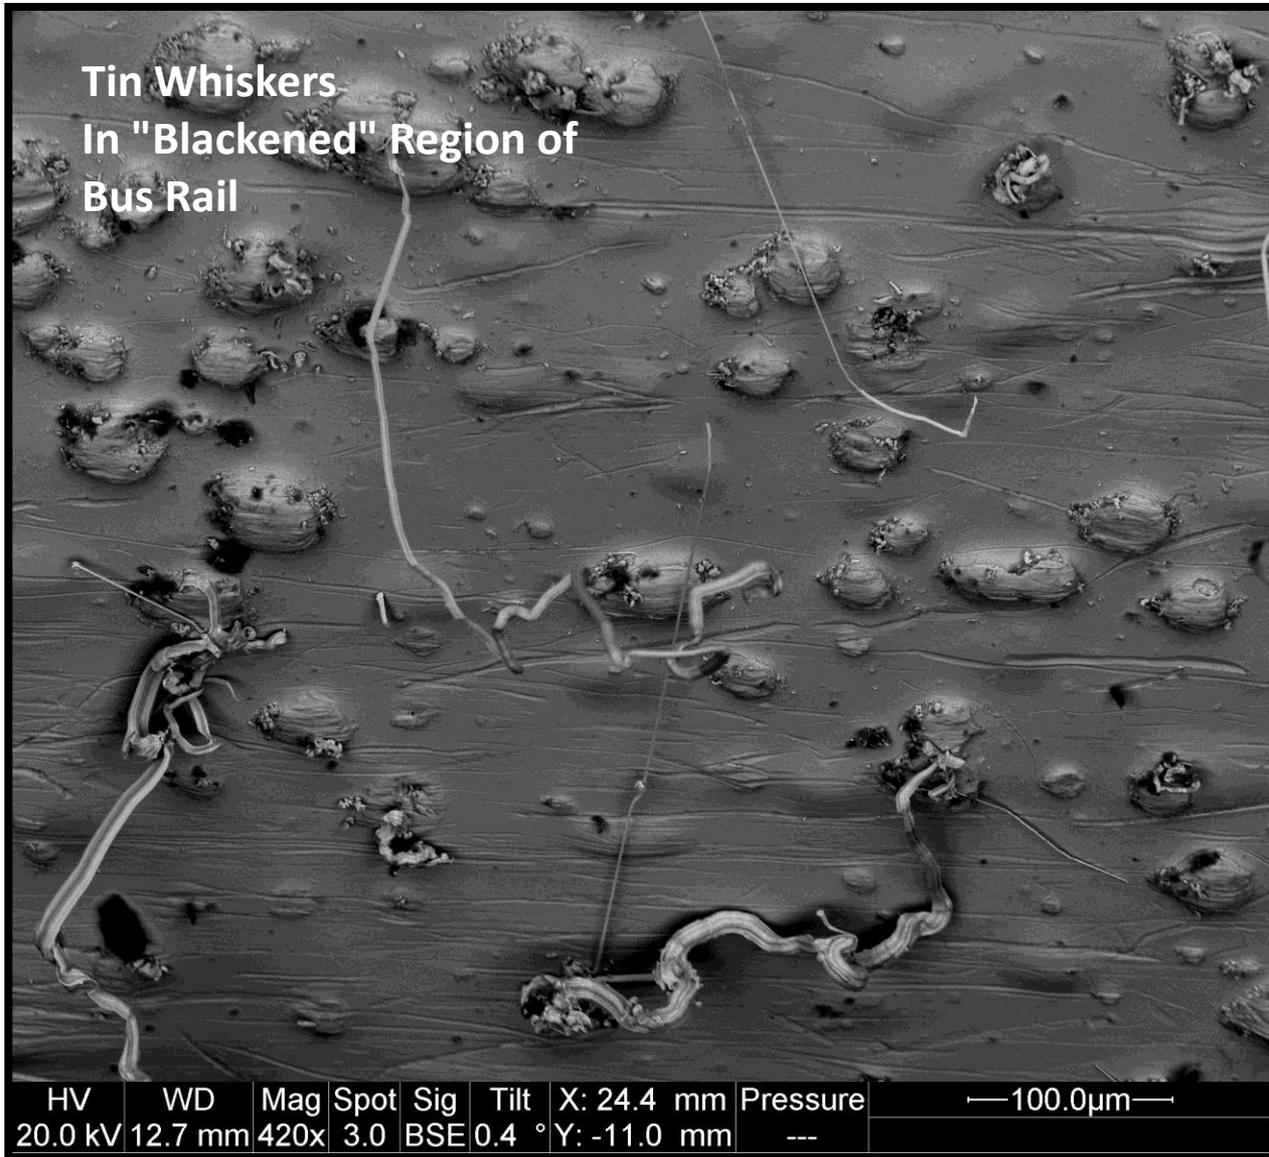
Tin Whiskers
In "Blackened" Region of
Bus Rail

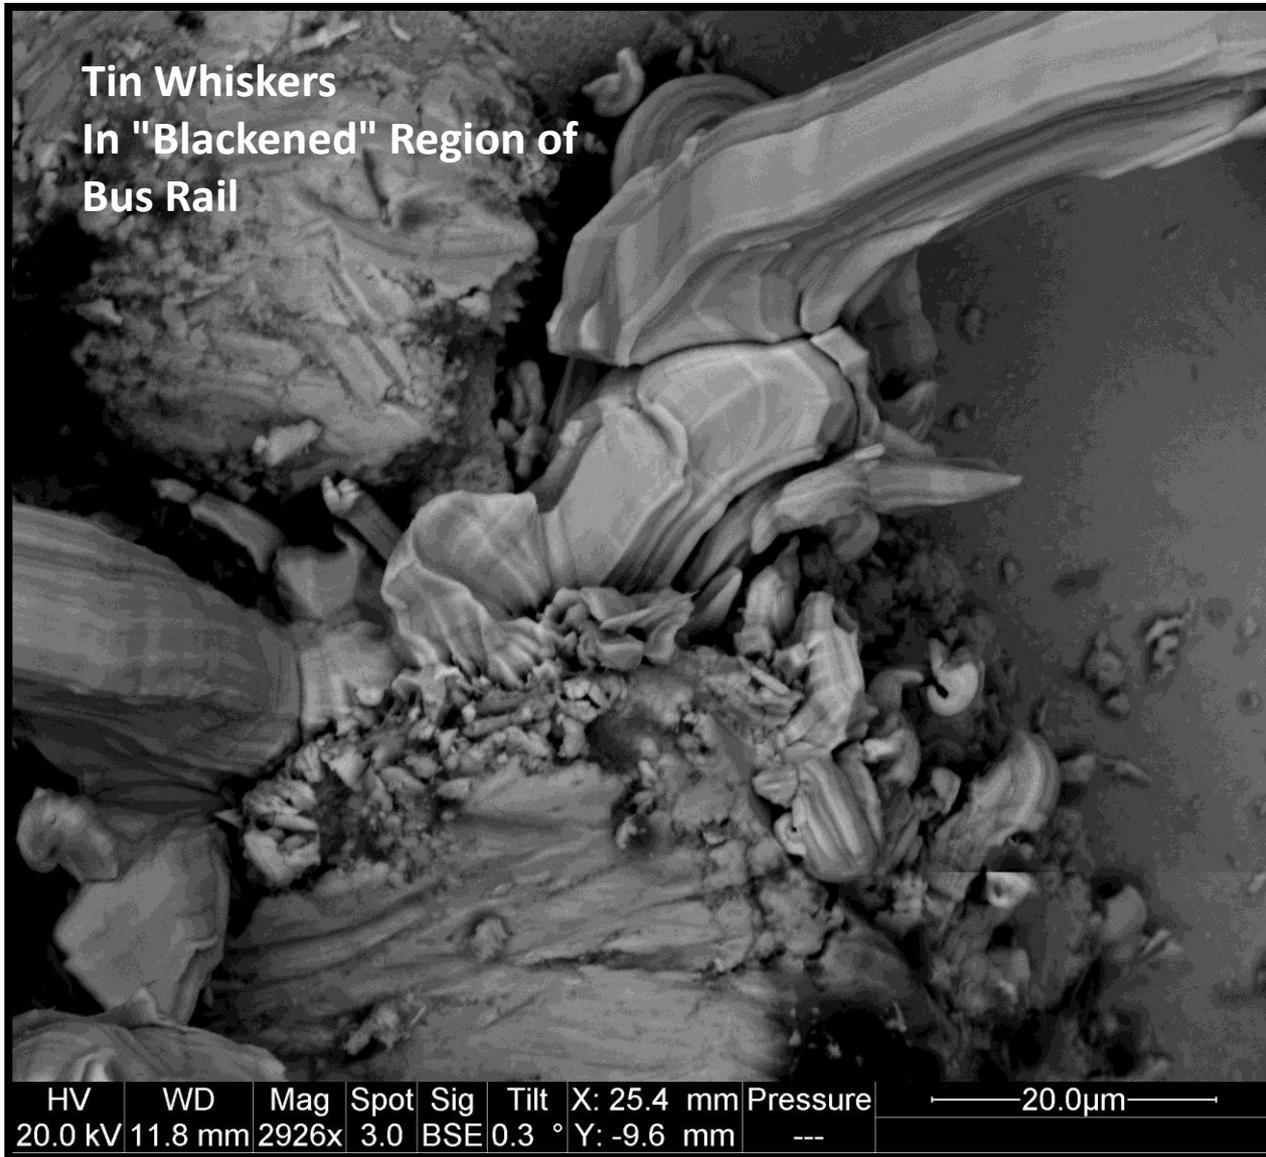
**Tin Whiskers
In "Blackened" Region of
Bus Rail**

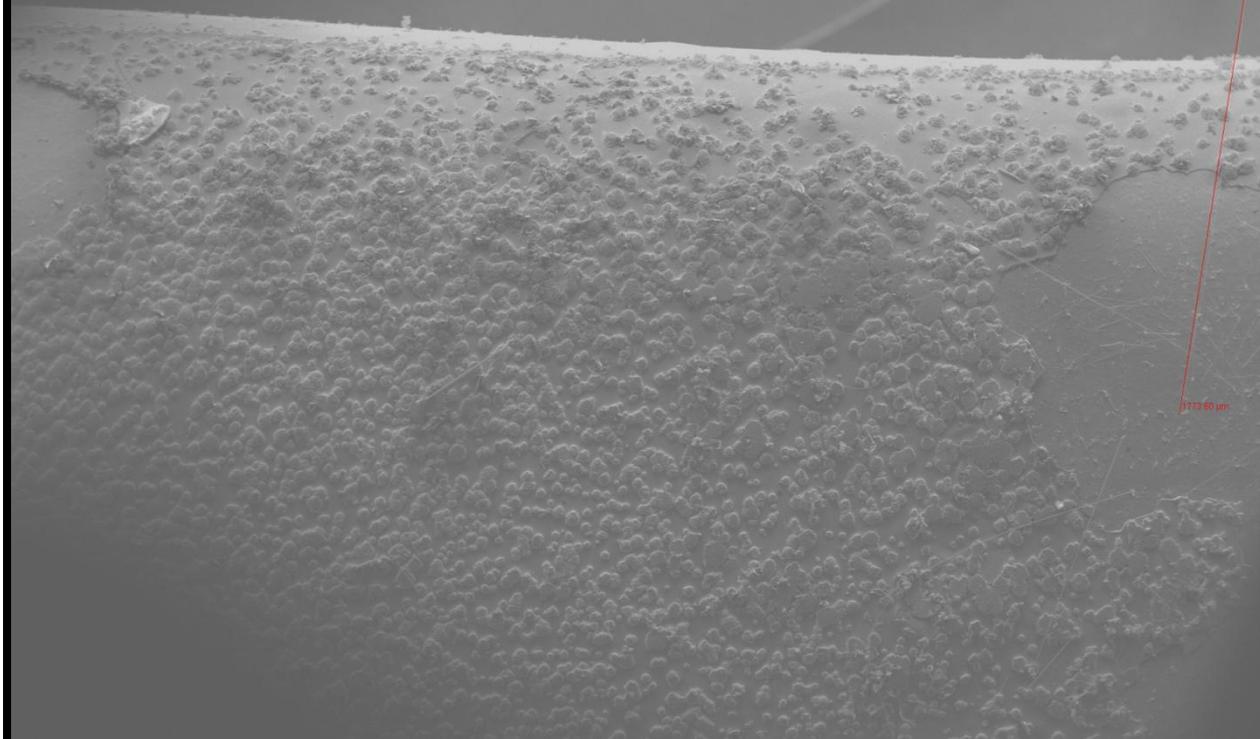
**"Blackened" Region of
Bus Rail with Large Areas
of Material Flaking Off**

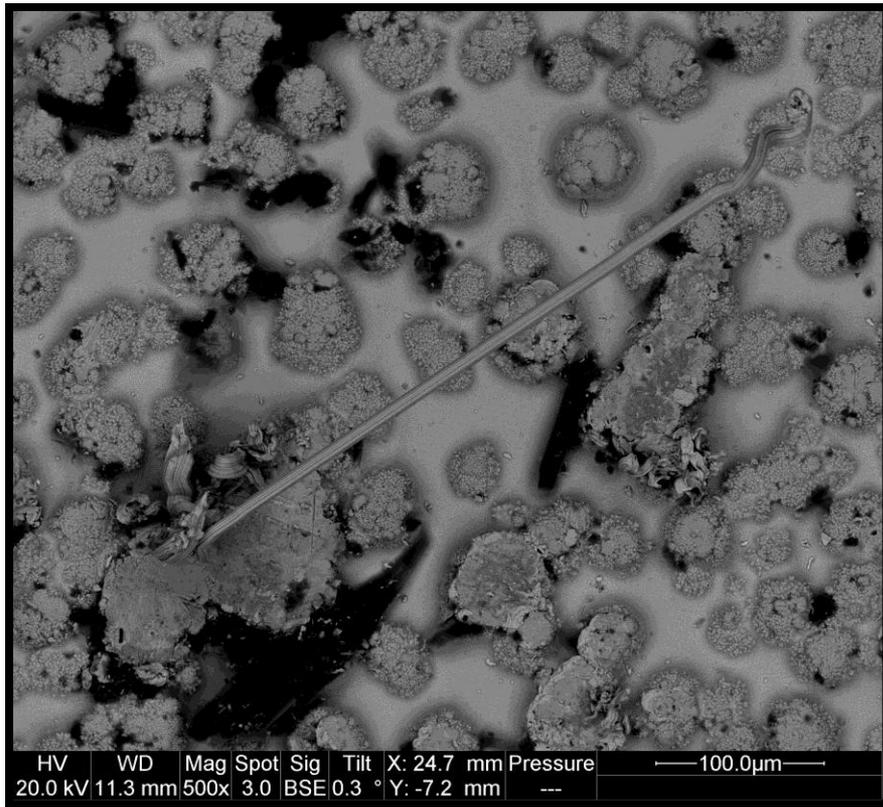
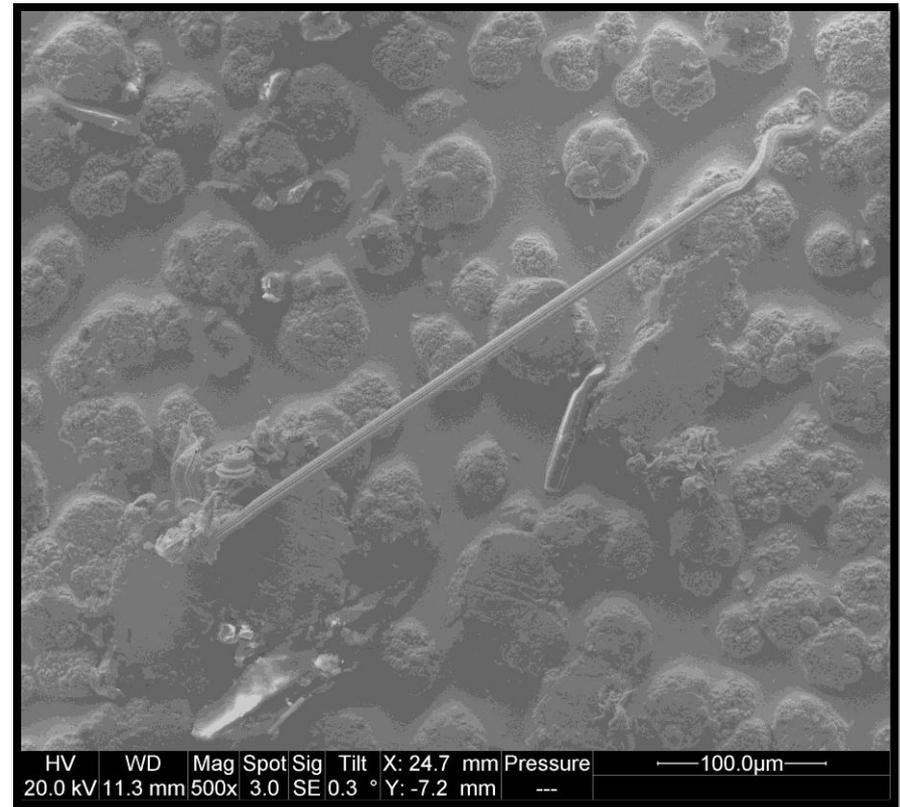
Tin Whiskers In "Blackened" Region of Bus Rail

Back Scatter Electron (BSE) view – difference in contrast represents different materials. Lighter colors are elements higher on periodic chart (in this case – tin), darker colors are elements lower on the periodic chart (in this case small debris, probably carbon)

Secondary Electron (SE) view – topographical image

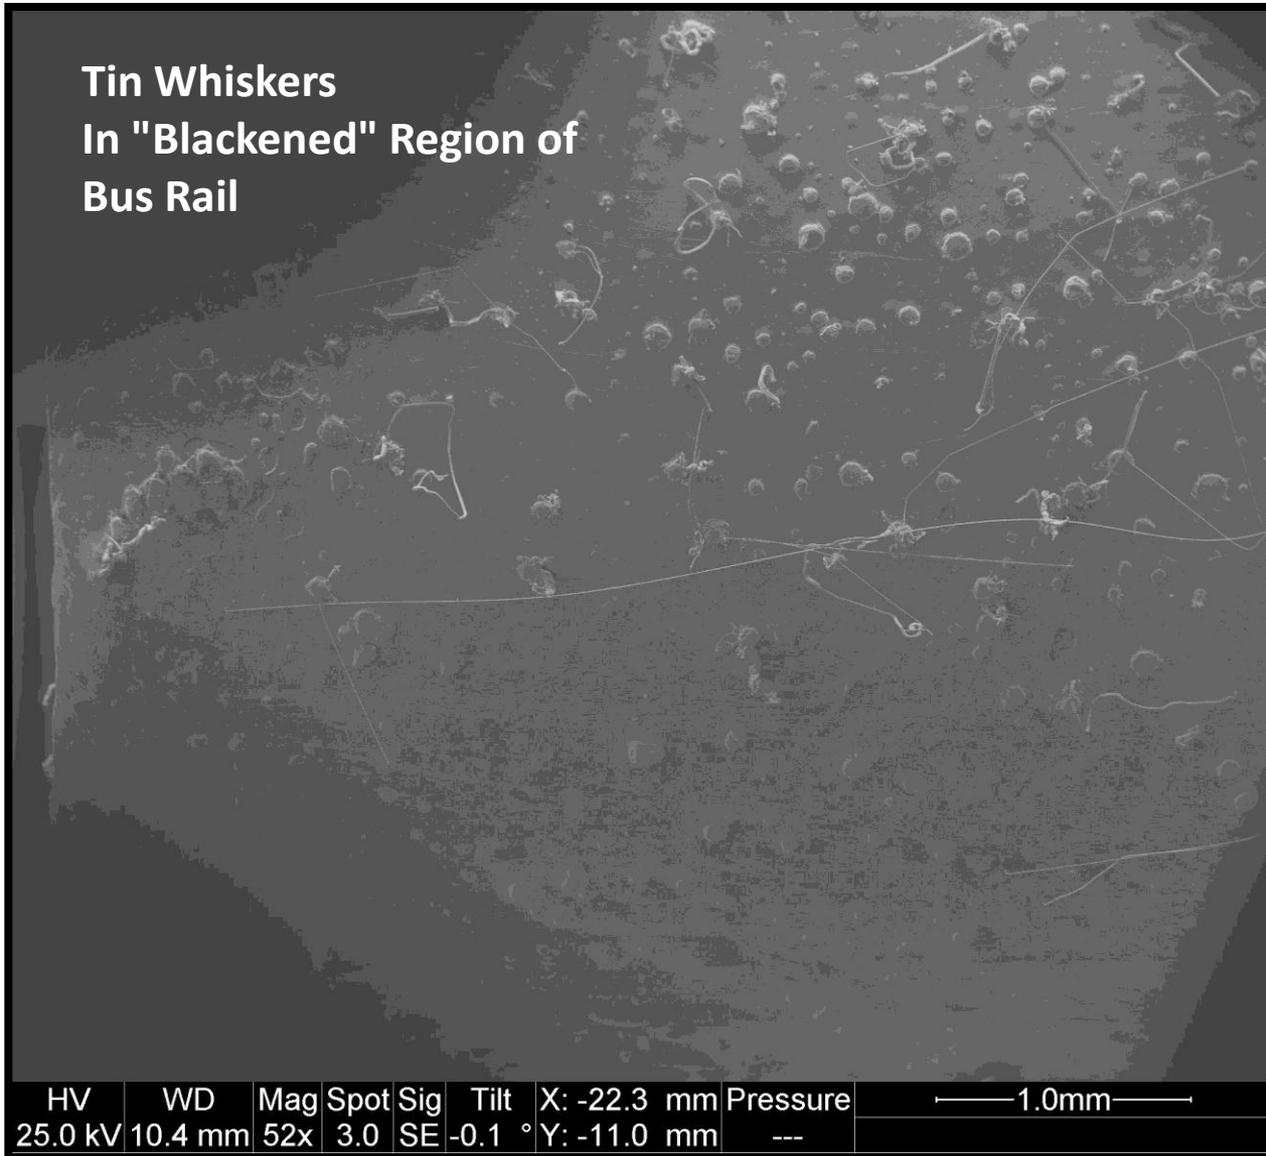
**Tin Whiskers
In "Blackened" Region of
Bus Rail**

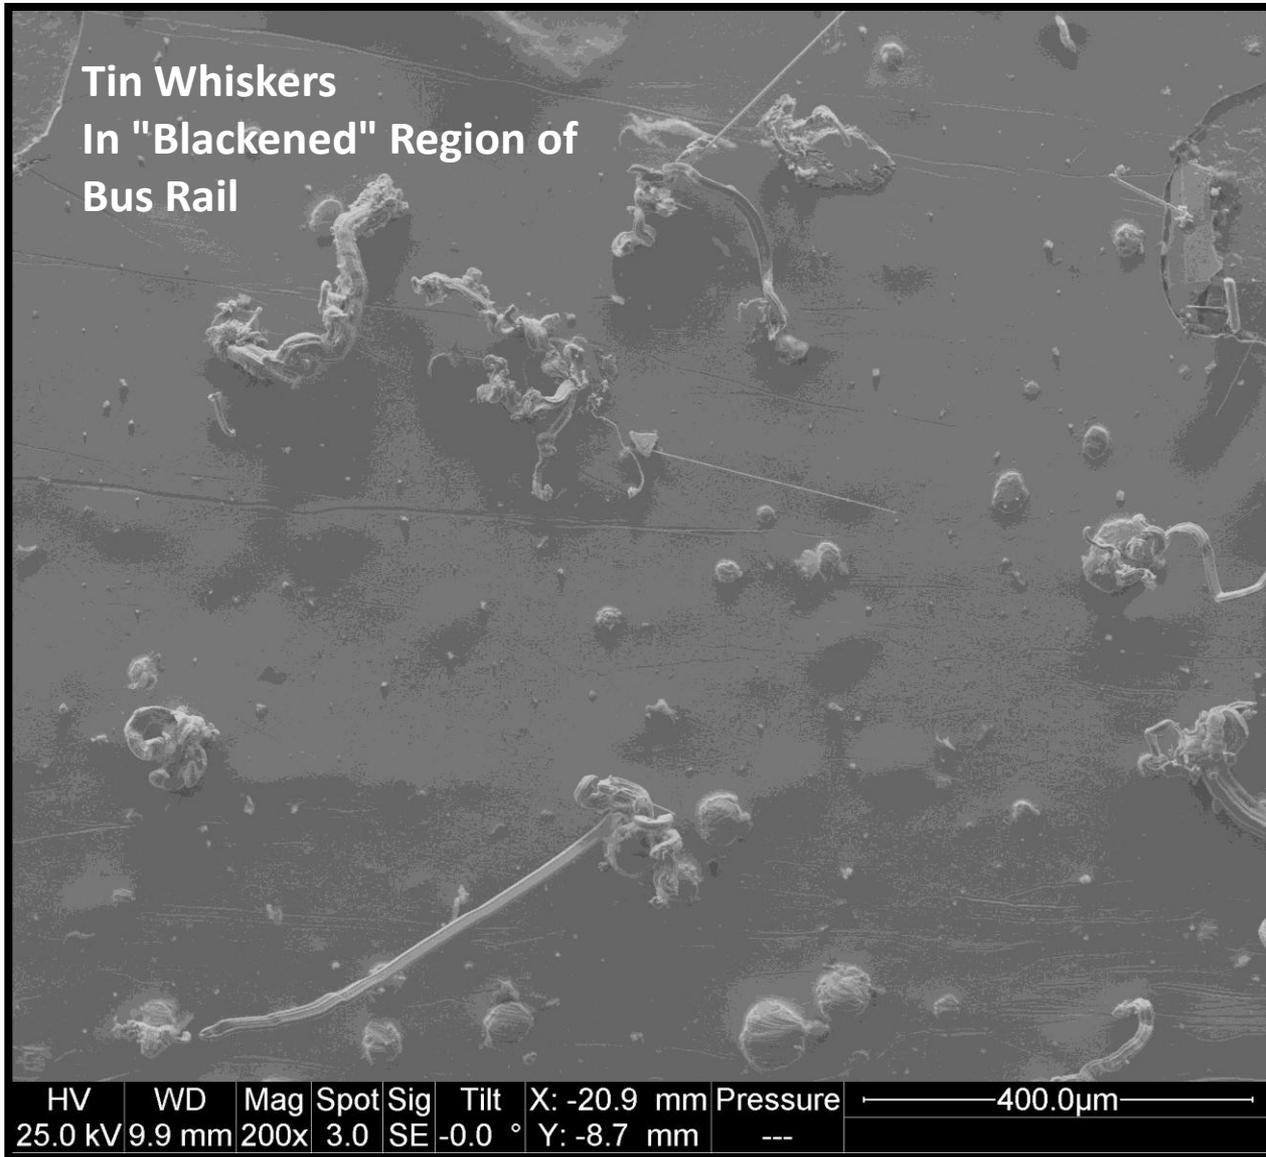
**Tin Whiskers
In "Blackened" Region of
Bus Rail**

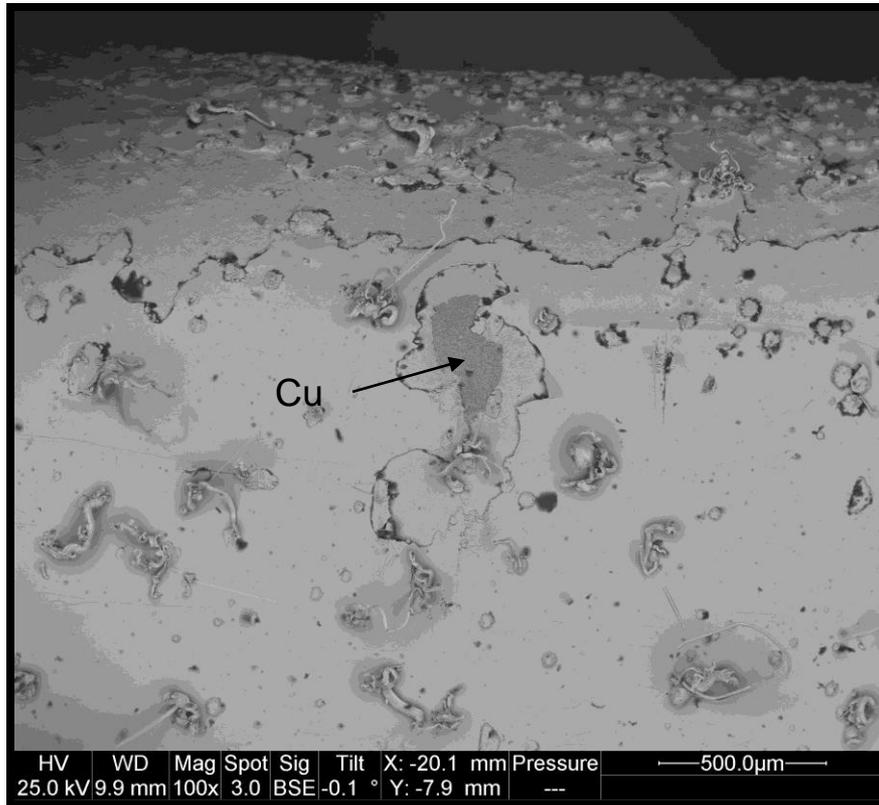
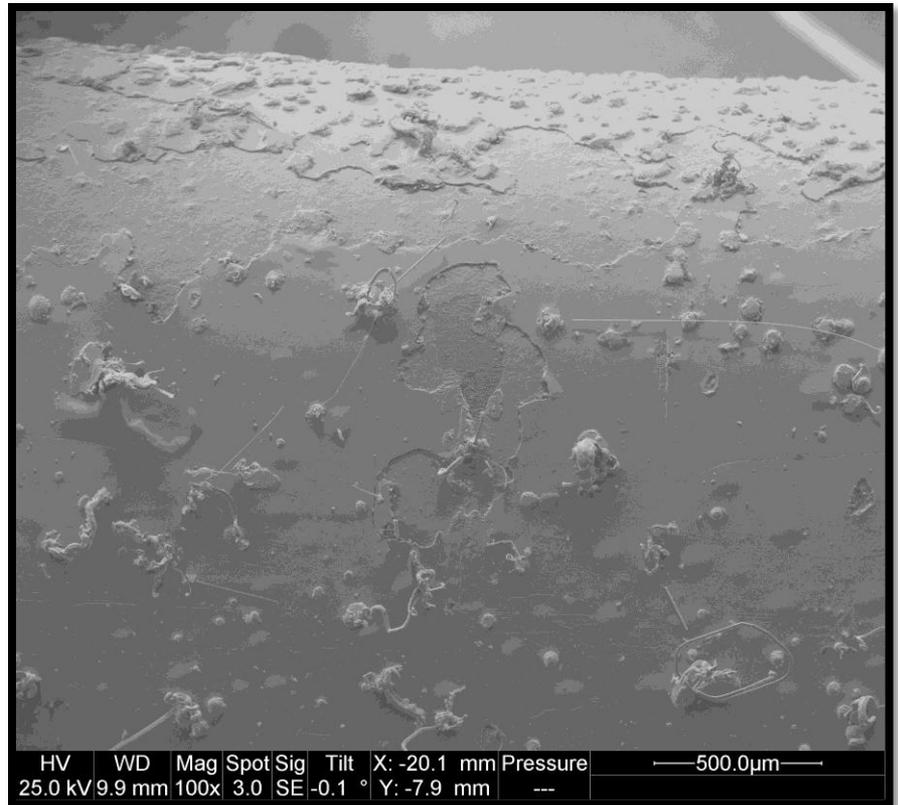
Tin Whiskers In “Blackened” Region of Bus Rail

BSE view – difference in materials

SE view – topographical image

Note: there seems to be flaking off of some tin coating. BSE image shows that most of flaked-off region exposes more tin underneath, but there is one area that exposes copper (Cu). See next slide for EDS analysis of this region

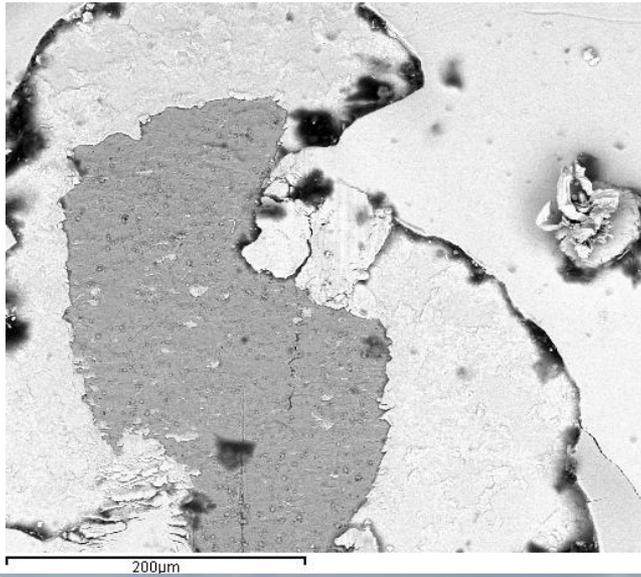
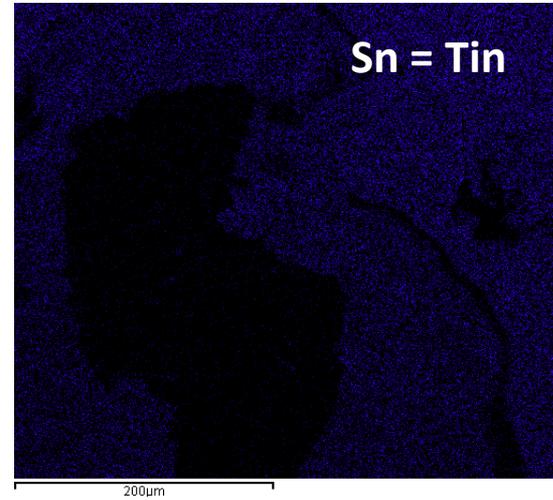
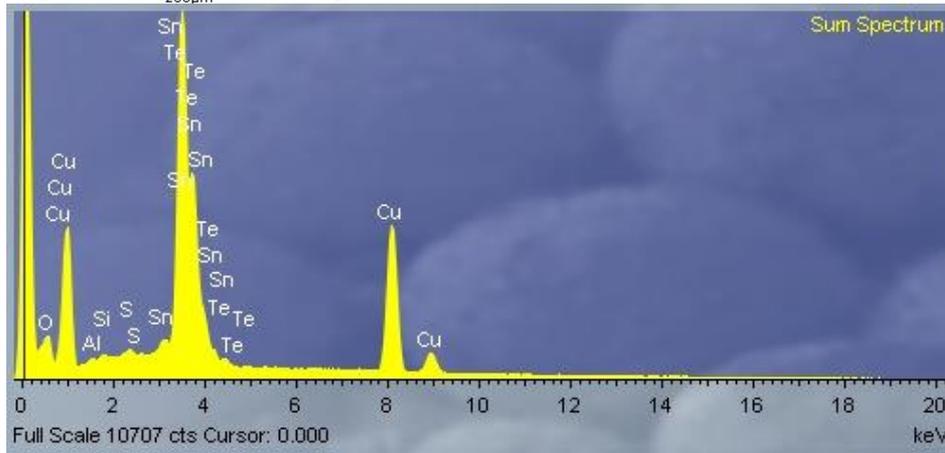
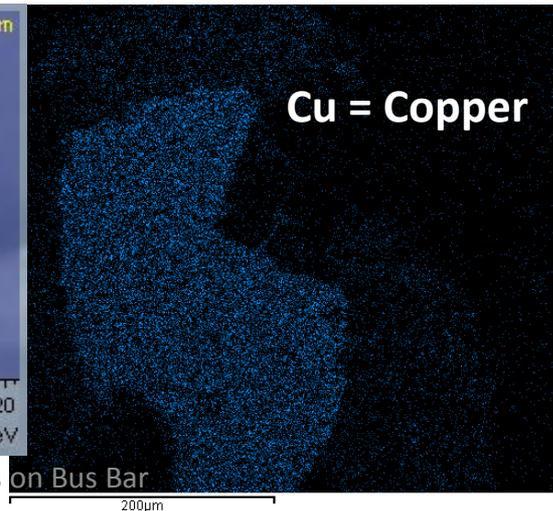
EDS Analysis of an Area Where Tin Coating Has Flaked Off

- EDS of this region shows only Sn and O (i.e., no C). May be very thick tin-oxide layer.

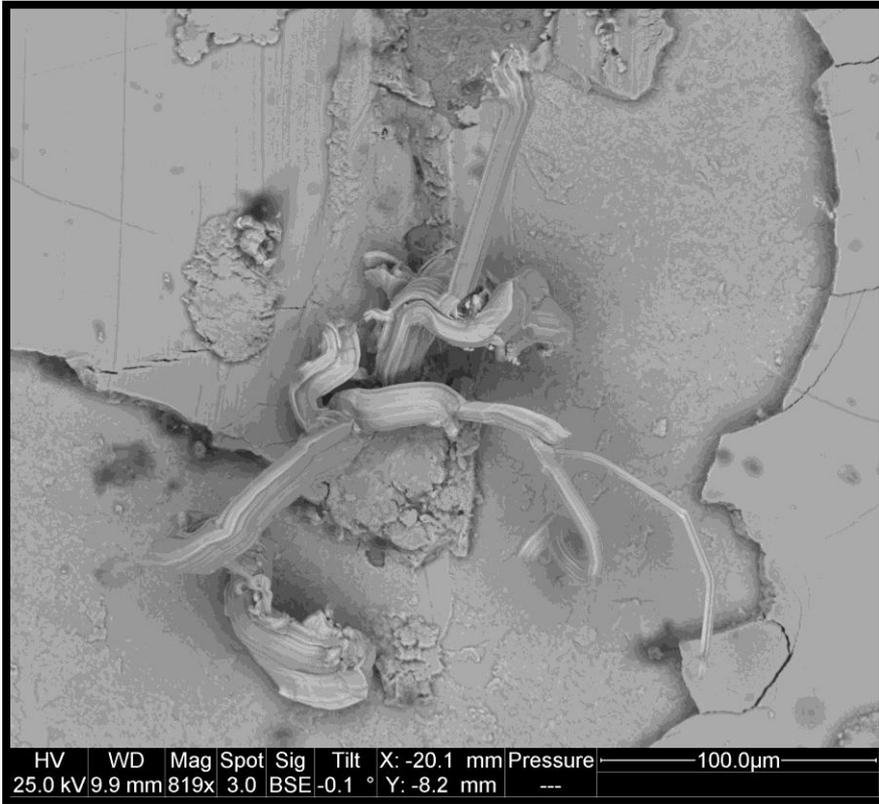
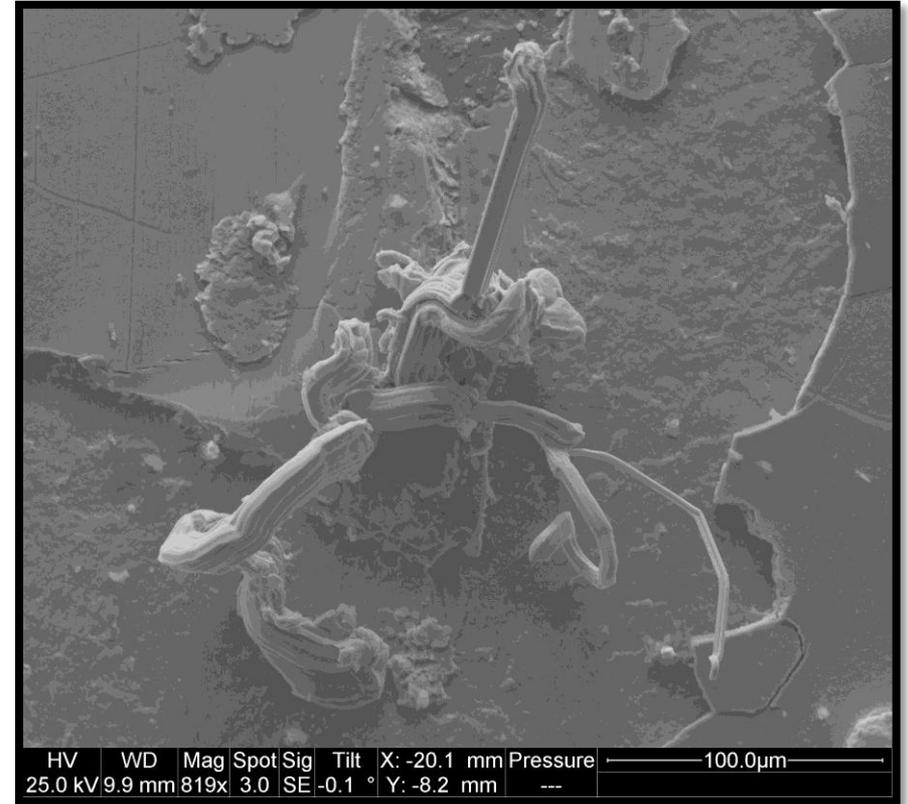
Tin Whiskers In "Blackened" Region of Bus Rail

BSE view – difference in materials

SE view – topographical image

The smoother regions in the picture are from a top layer of tin, while rougher regions are an exposed layer of tin from top layer flaking off
